**PRESERVATION AND URBAN RELIGIOUS INSTITUTIONS:  
OPPORTUNITIES AND STRATEGIES FOR THE PRESERVATION OF THE  
NINETEENTH STREET BAPTIST CHURCH**

Molly Anne Sheehan

A THESIS

Historic Preservation

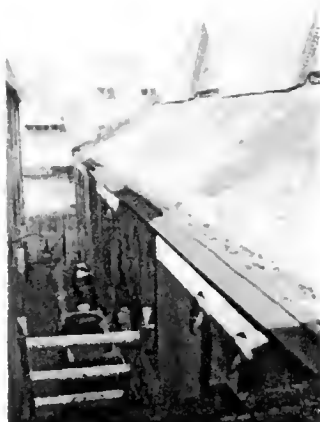
Figure 4 Roof over south side aisle of sanctuary below clerestory dormers

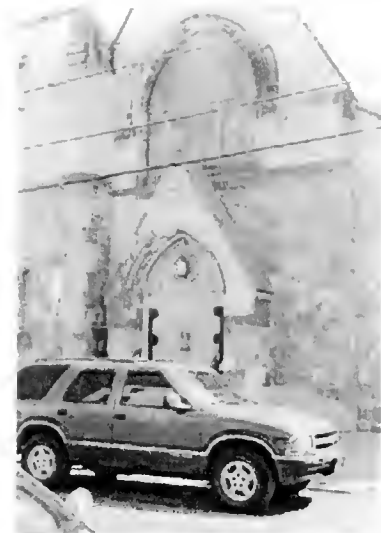
**Figure 11** The main entry at the west side of the sanctuary shows surviving stucco above the belt course and exposed, deteriorating serpentine below.

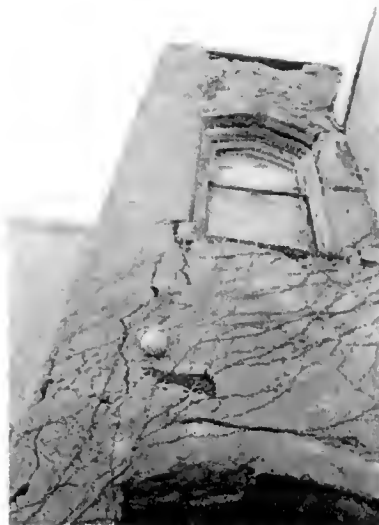
**Figure 13** Fire tower viewed from grade

Unless such a difficult decision can be made immediately, urgent stabilization measures must proceed at the two collapsing areas beginning with the fire tower.

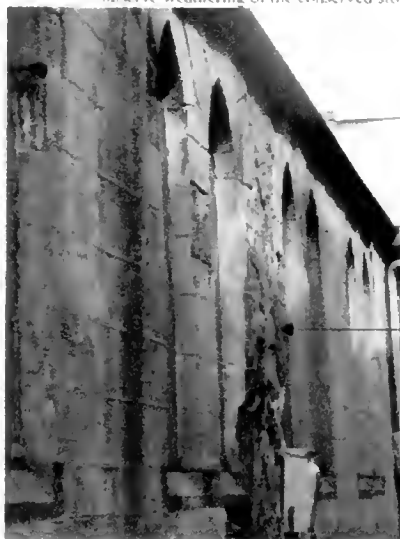
Recommended test  
area

3. *Test areas of injection grouting and stone conservancy* - This phase of work would be probably best placed in the fenced alcove on the West elevation, between the Church and the Hall. Here non-destructive testing techniques as well as grouting techniques can be evaluated, as well as stone conservancy techniques. A benefit to this approach is that this very visible work could aid in developing contributions for the restoration effort, as well as providing a place to observe weathering of the conserved stone.

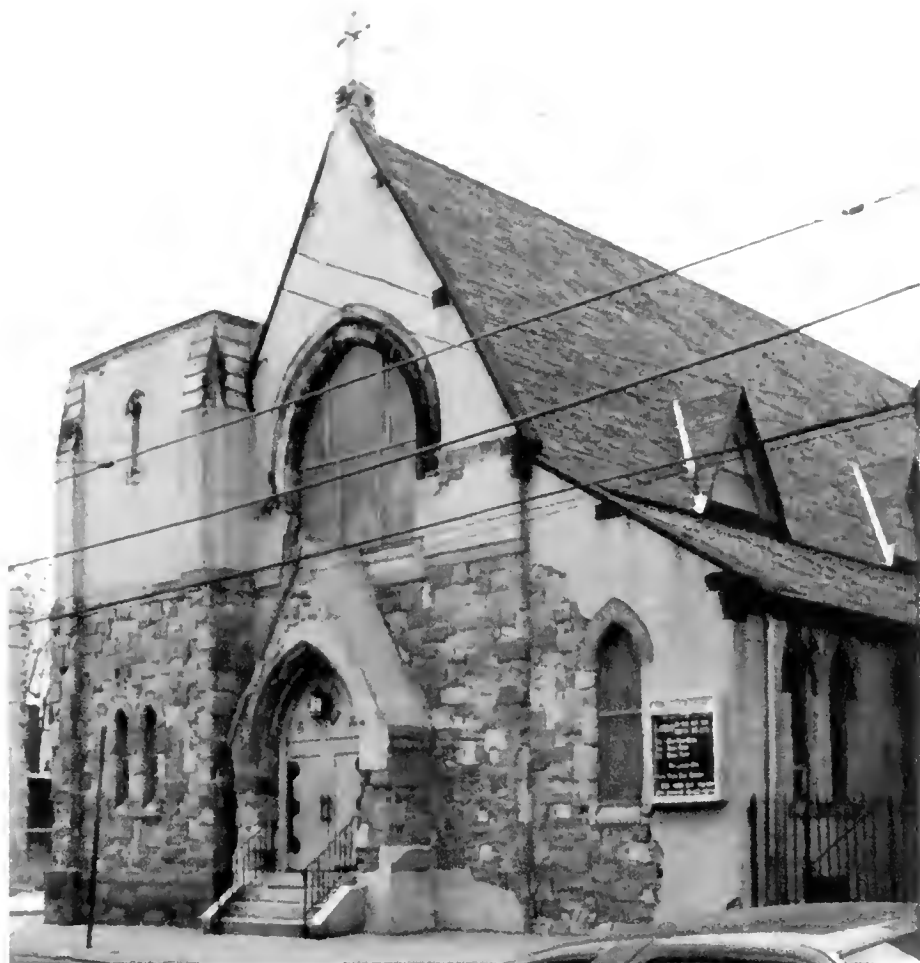
West Façade of Church Building (A)

The original belfry/tower at the corner of 19<sup>th</sup> Street and Titan Street has been truncated. No access was attainable to the roof area making an estimate of condition impossible. (refer to photographs A, B and F)

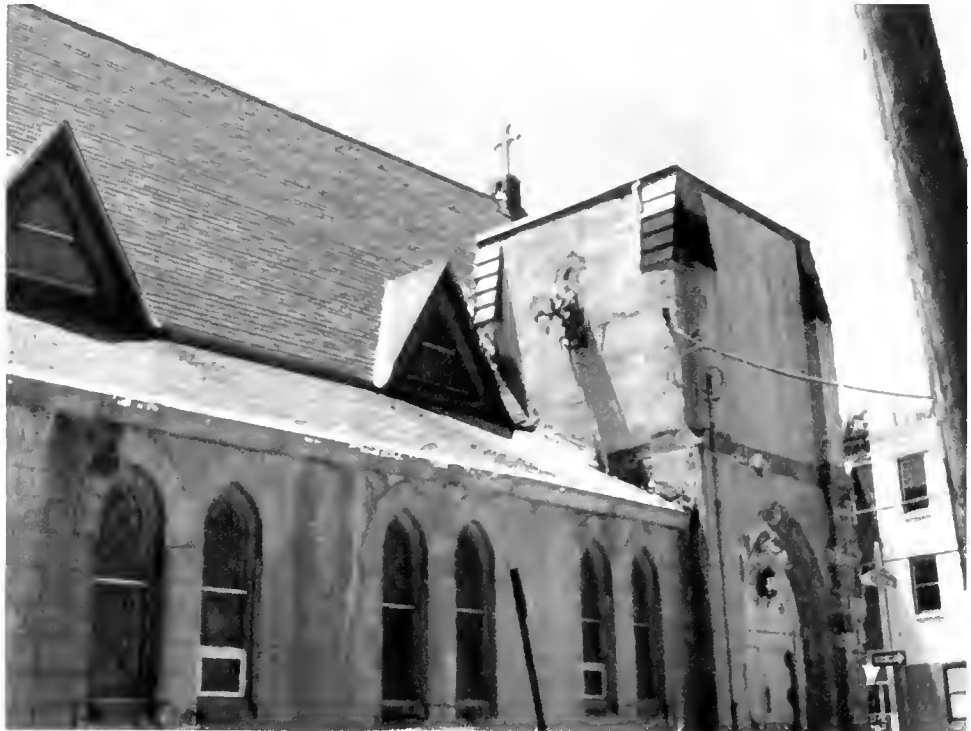
North Elevation of Church Building (H)

<b>Other Features:</b> The back quarter of the north elevation has undergone alteration after a recent explosion. Brick has been inserted to recreate a connection between the masonry wall and the roof. Much patching work is observable in this area. (refer to photograph P) The truncated belfry/tower is observable from this elevation. There is noticeable invasive vegetative growth on the tower. (refer to photographs H and I)

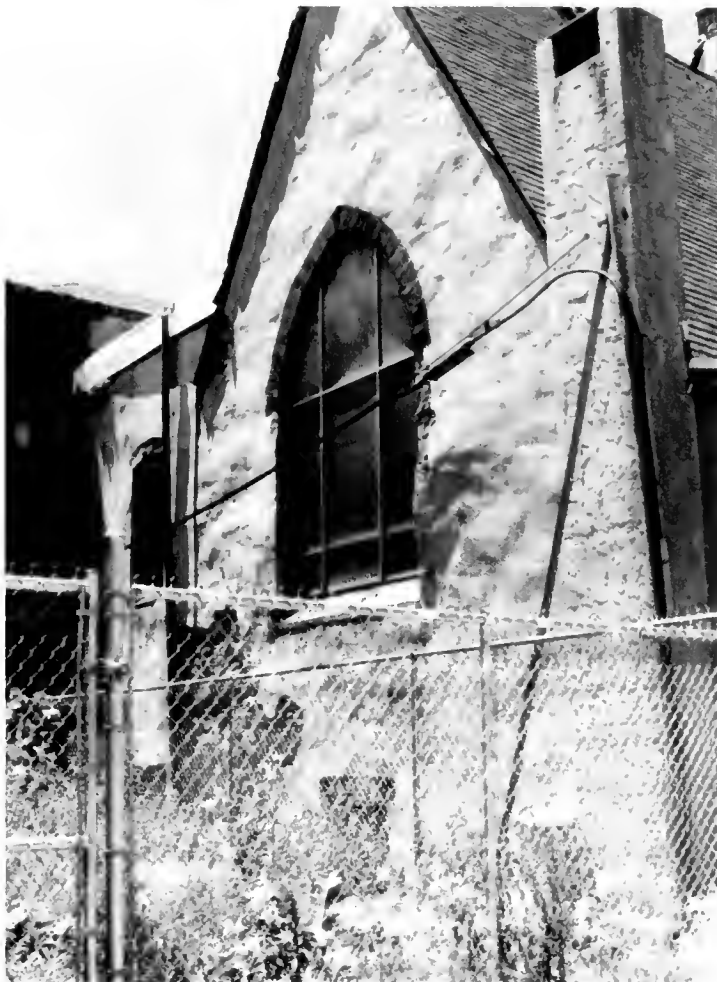
East Elevation of Church Building (Q)

**Other Features:** This elevation has a chimney at its northeast corner. It too has been coated in stucco. The roofline observable at this elevation has been complicated by an addition. (refer to photograph Q)

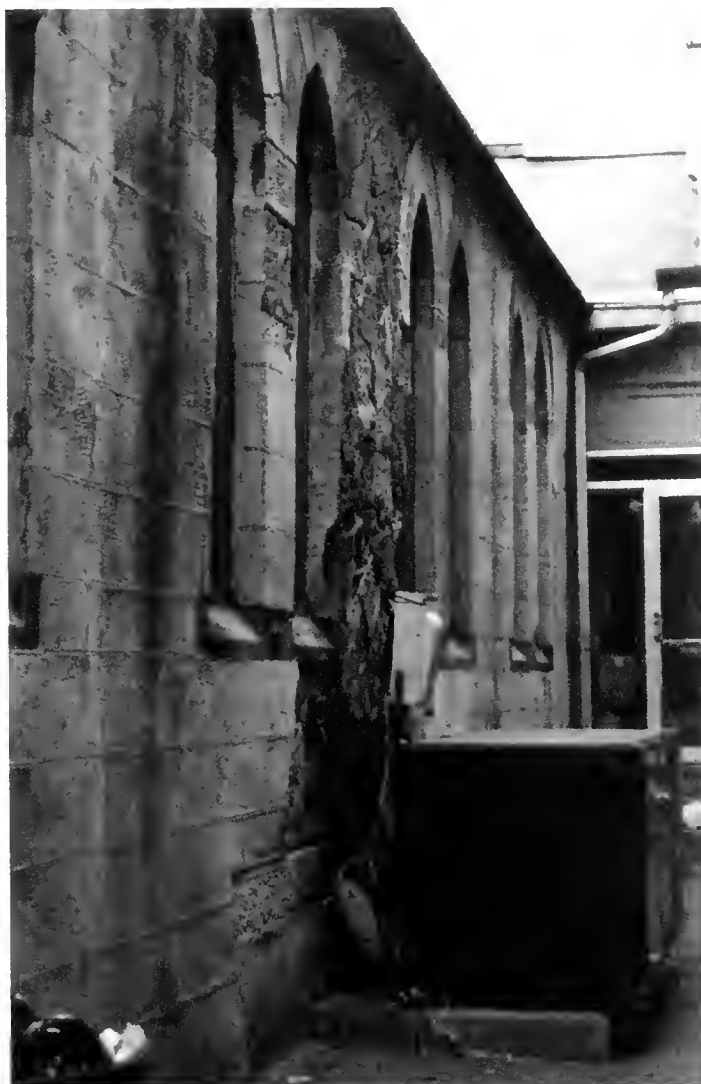
South Elevation of Church Building (U)

<b>Other Features:</b> There is a mechanical system located near this elevation with a box that has been attached to the stucco. (refer to photograph U)
